National Civil Protection Organization and technical activities in the 2012 Emilia earthquakes (Italy)

Mauro Dolce & Daniela Di Bucci

Bull Earthquake Eng (2014)

DOI 10.1007/s10518-014-9597-x

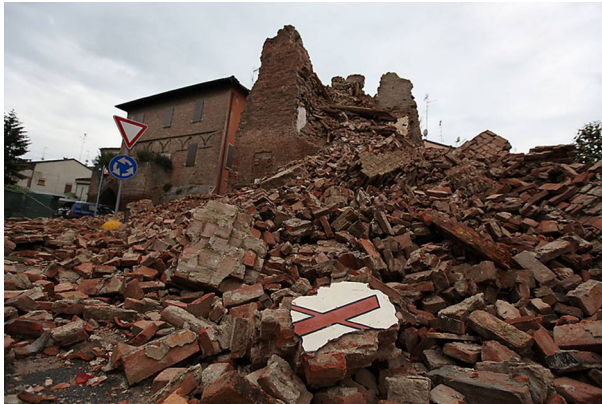
Fig. 1 Collapsed clock tower; Finale Emilia (from <http://www.protezionecivile.gov.it/>)

Considering the earthquake effects, three kinds of buildings have suffered the most serious consequences: (i) monumental buildings (churches, towers and bell towers, castles, palaces;

Fig. 1); (ii) buildings for industrial use (especially prefabricated buildings); (iii) masonry rural buildings (farmhouses, storehouses).

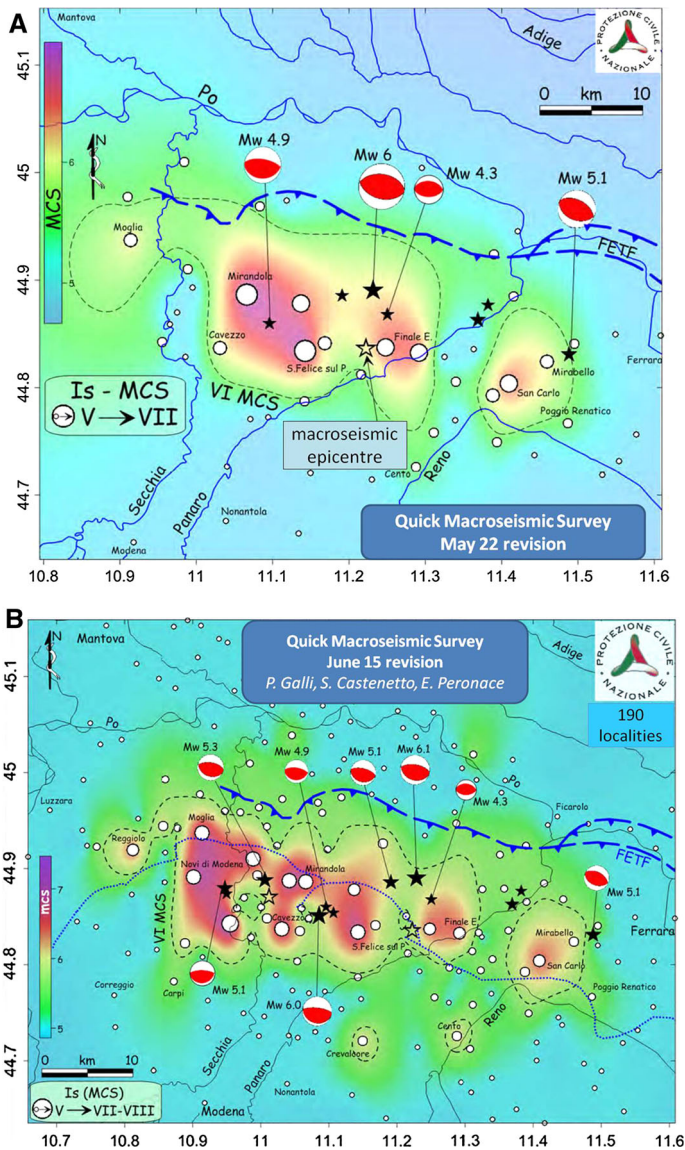
Fig. 3 Macroseismic fields (a) between the first and the second main shock and (b) after the second main shock (Galli et al. 2012). **A** Surveys up to May 22nd, **B** Surveys up to June 15th

di Modena (VII MCS), Concordia sulla Secchia (VII MCS) and, especially, at Rovereto, a village in the municipality of Novi di Modena (Fig. 3).

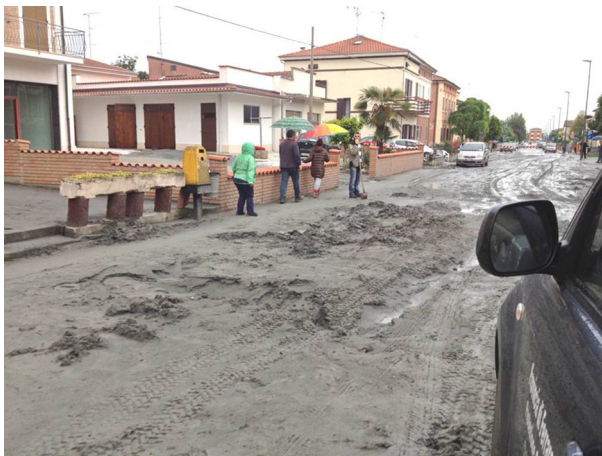
Fig. 4 Example of liquefaction phenomena (from <http://www.protezionecivile.gov.it/>)

Liquefaction mud came at surface through fractures up to ~50 m long; fractures width ranged from few centimetres to some decimetres. In some cases, the formation of typical mud volcanoes was observed; in other cases, mud was ejected through large diameter water wells, or it uplifted pavements in urbanized areas.

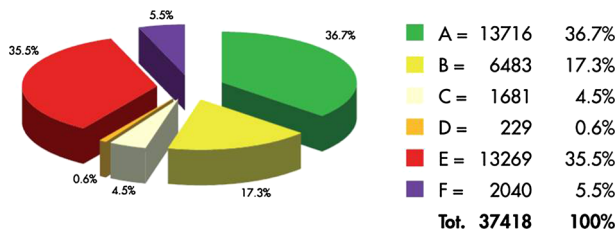
Fig. 7 Results of the damage and usability assessment, referred to August 3rd, 2012, and distributed according to the AeDES categories

The results of the survey are shown in Fig. 7 and, for their correct interpretation, they deserve to be briefly commented. The amount of usable buildings (category A) corresponds to the 37 % of the inspected buildings, and is significantly lower than the percentage obtained for the same category after the April 6th, 2009, Abruzzo earthquake (Dolce et al. 2009), which was of the order of 50 %. Moreover, in the Emilia case, the percentage of usable

buildings is quite the same as that relevant to unusable buildings in category E. For the Abruzzo earthquake, instead, the buildings assessed under category E were 25 %, in spite of the maximum observed macroseismic intensities being more than one degree higher than those assigned for the Emilia earthquakes.

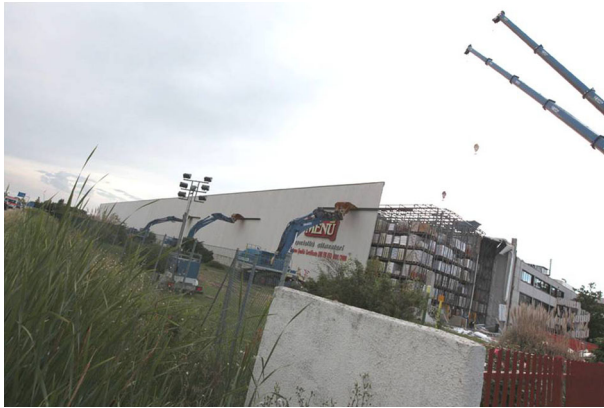
Fig. 8 Example of a strongly damaged warehouse at Moglia (from <http://www.protezionecivile.gov.it/>)

- the lack of structural links between horizontal (beams, double tee roof decks, etc.) and vertical (columns) prefabricated structural elements;
- the use of very heavy prefabricated wall panels, inadequately anchored to the main structure, or so that unfavourable interactions were generated;
- the occurrence of notably heavy duty warehouse racks poorly or not at all braced, containing very heavy goods. The collapse of these stands caused an unexpected horizontal thrust on the main structure, favouring in turn its collapse (Fig. 9).

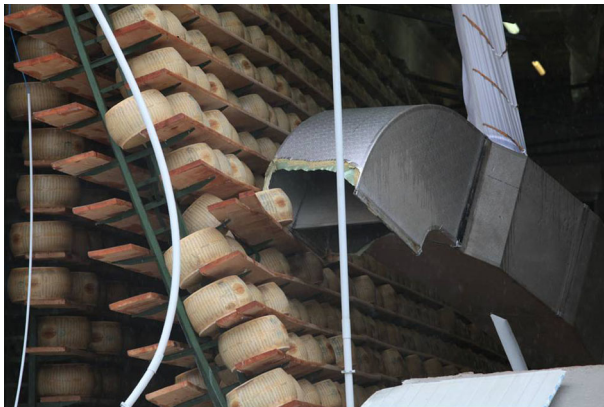
Fig. 9 Example of collapsed stands within a warehouse in the Moglia village (from <http://www.protezionecivile.gov.it/>)

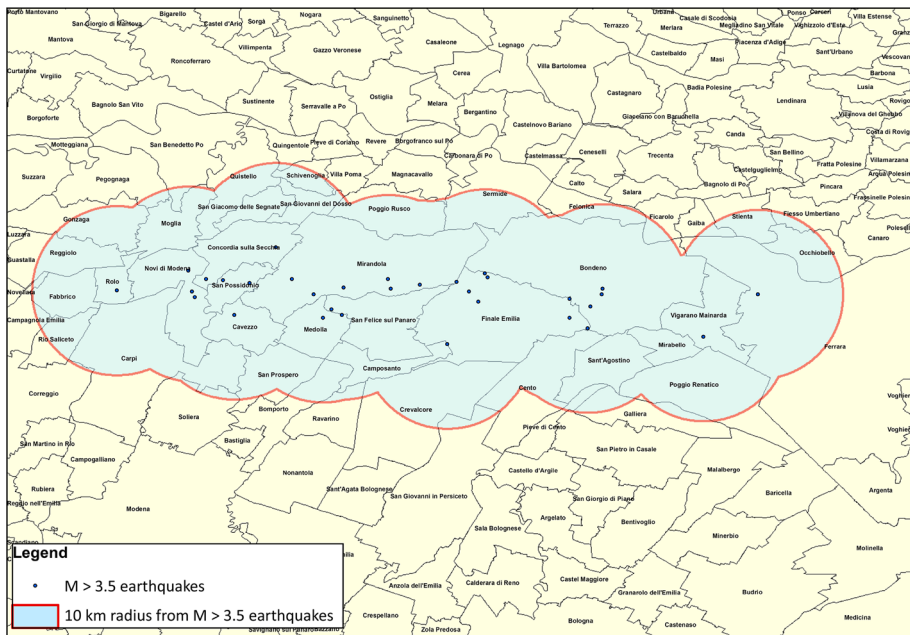
Fig. 10 Map of the 52 municipalities within a 10 km radius from the epicentres with $M > 3.5$
